Ping Monitor

Continuous Non-Contact Blade Damage Detection
SYSTEM OVERVIEW AND RESULTS

White Paper February 2020

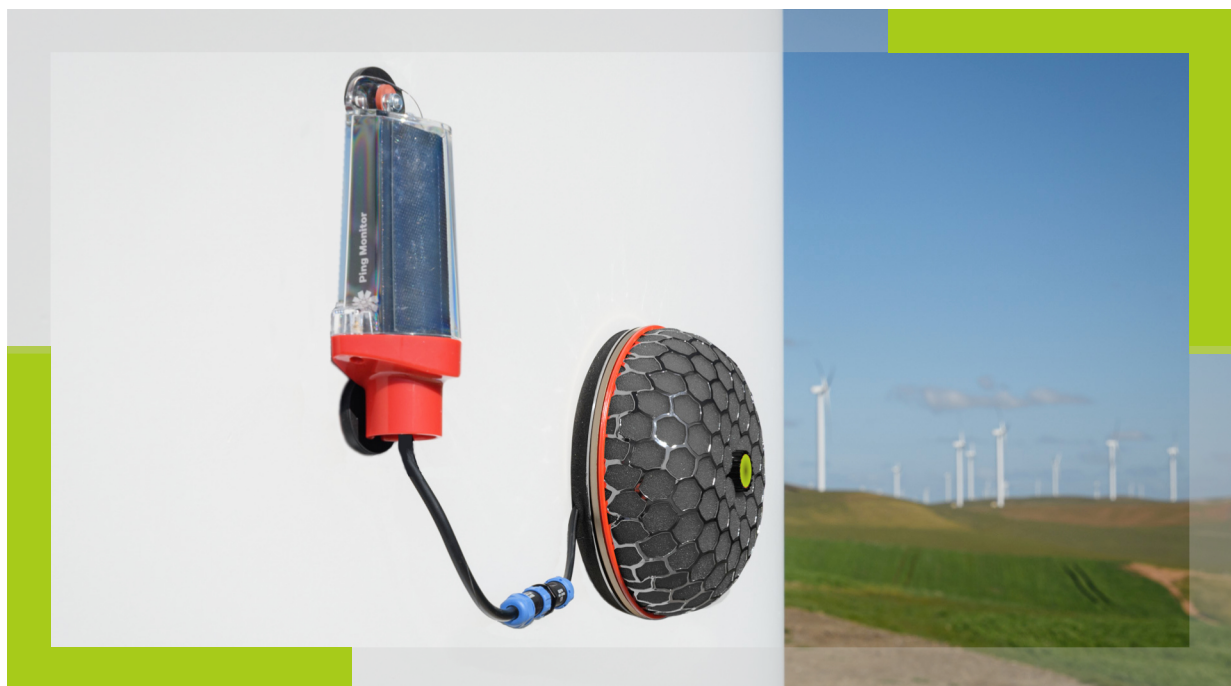
Figure 1 - The Ping Monitor installed on a wind turbine with magnet mounts

The Ping Monitor hardware consists of an outer replaceable wind shield, inner housing which contains the microphone and other electronics, and a base board. The wind shield is an inverted conical shape, with a base diameter of 300mm, and height of approximately 250mm. A picture of the hardware can be found in Figure 1.

The tower mount version is fitted with a quick mount magnetic bracket, allowing for the Ping Monitor to be placed directly on the side of a steel wind turbine tower. The pole mount version is normally installed approximately 30 m from the base of the tower, and is provided with a bracket that allows for the unit to be fixed to the top of a fence post, star picket, or similar.

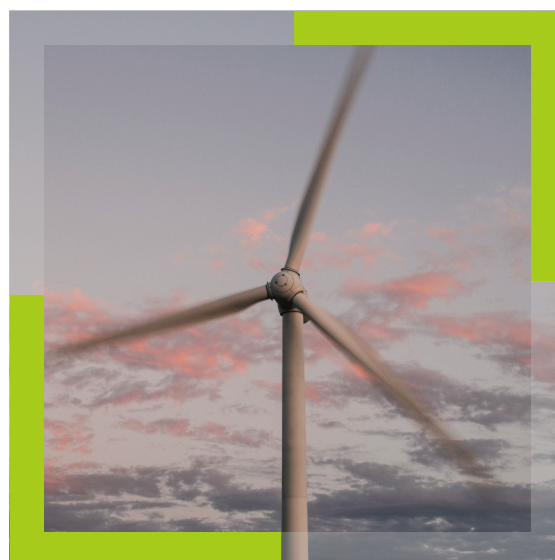
Figure 2 shows two examples of acoustic signals that were measured from two wind turbines, one with blade damage and a second one without blade damage. These signals illustrate a clear difference in the acoustic signature generated by two otherwise identical turbines operating under the same wind conditions.

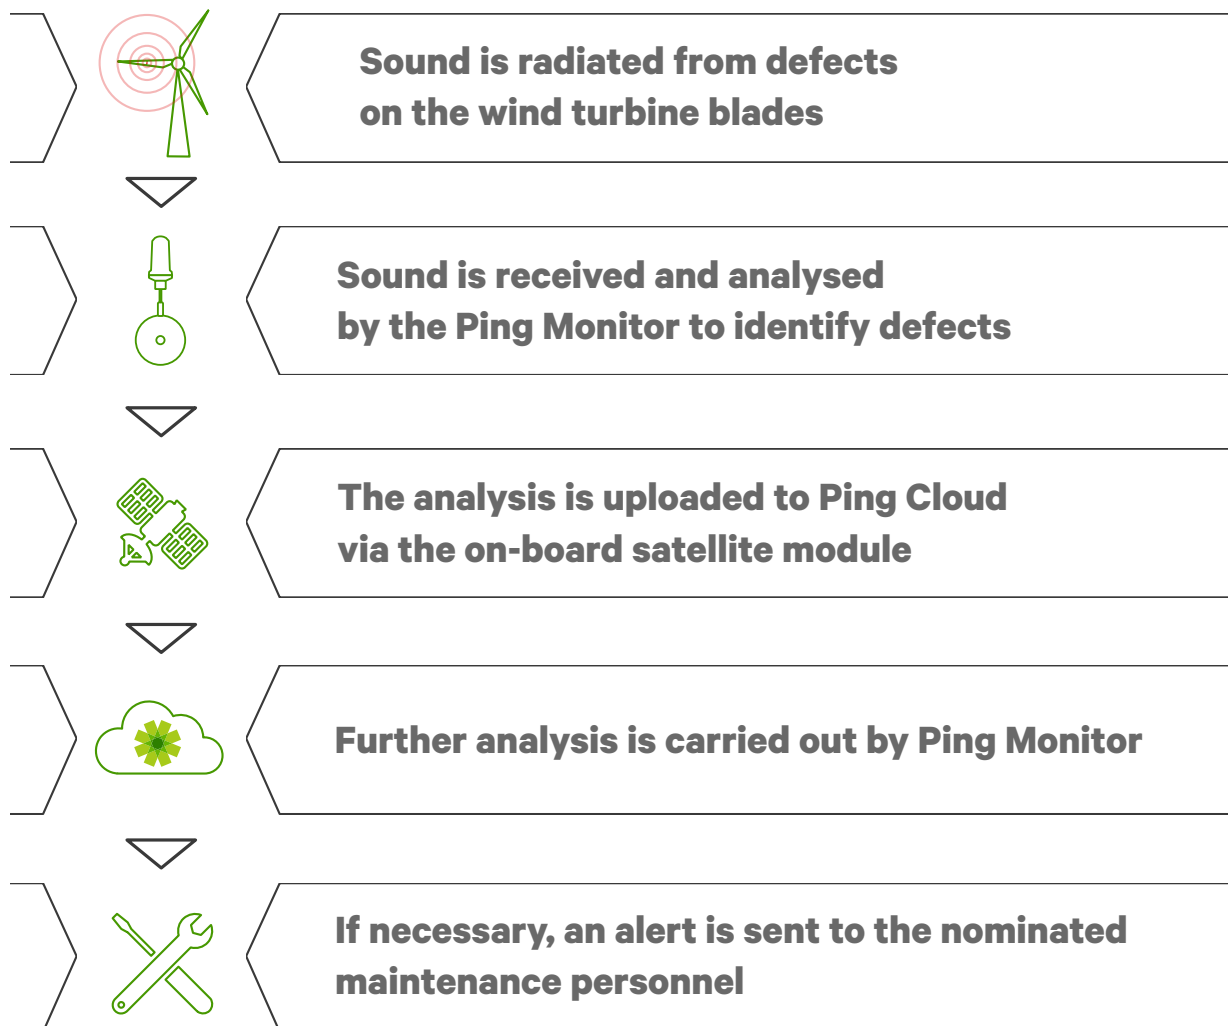
Figure 3 provides an outline of the Ping Monitor operation, with further detail provided in the following sections.

Figure 3 - Outline of the Ping Monitor operation

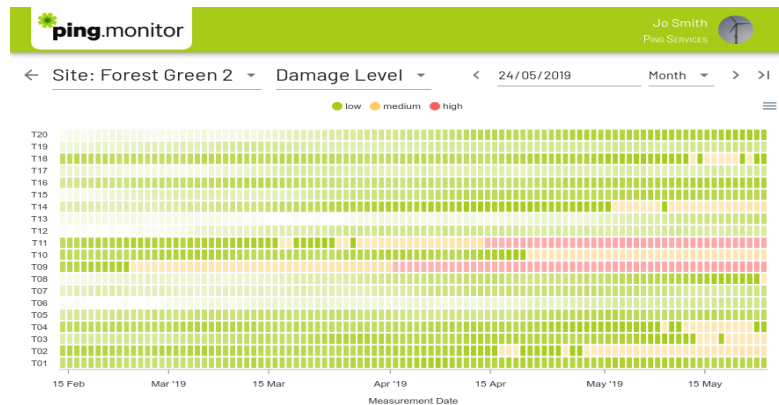
Figure 4 - Ping Cloud, comparison of turbines and tracking over time

Ping Cloud provides maintenance supervisors with a visualisation of the trending and comparison of turbine damage at a turbine, site and fleet wide level.

Two example screen shots from the Ping Cloud are provided in Figures 4 and Figure 5.

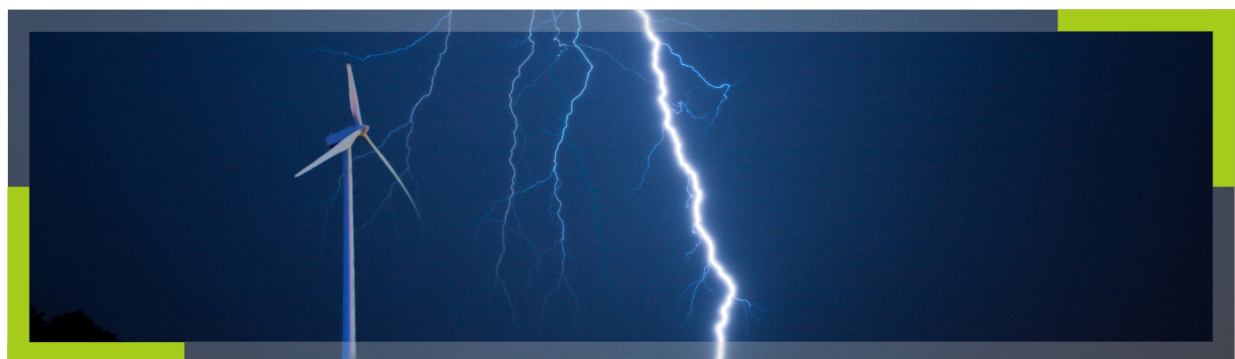
Figure 6 - Photos of some of the damage detected using the Ping Monitor.

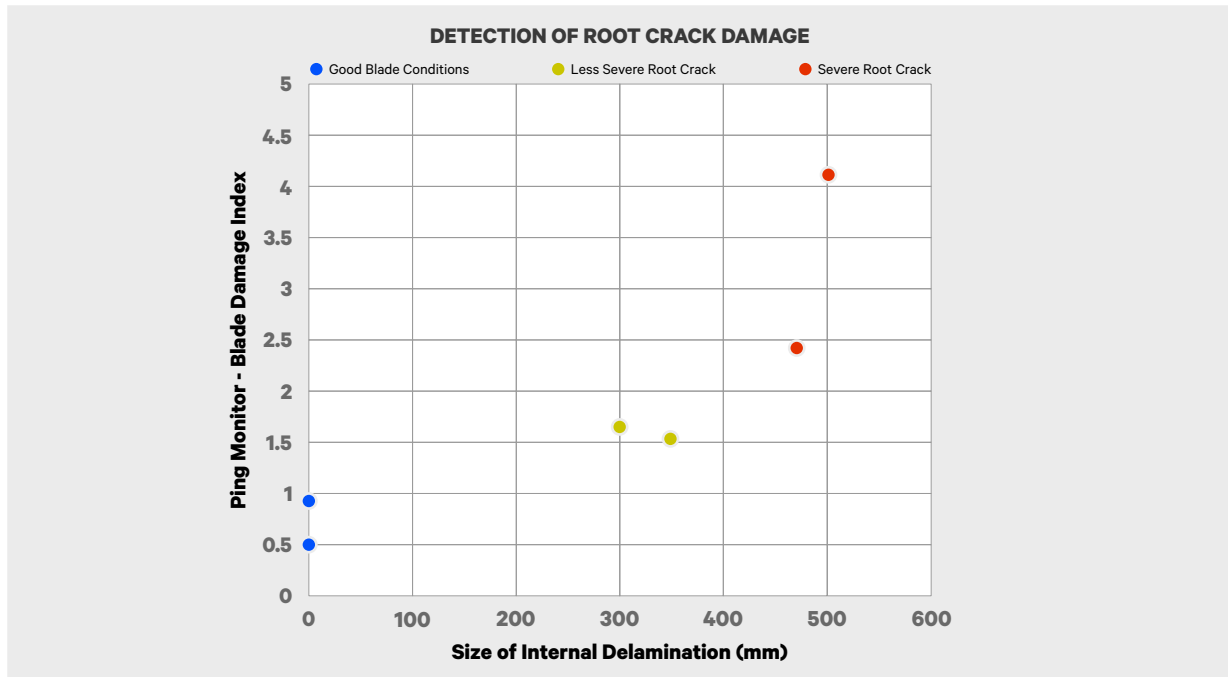
The Ping Monitor successfully identified which of the turbines had the most, least, and no damage. A plot showing the relationship between the blade damage detected and the size of the internal delamination of the root cracks is provided in Figure 7.

Figure 7 - Relationship between actual damage size and damage severity detected using the Ping Monitor

From the graph in Figure 7 it can be seen that minimal blade damage was detected at the two turbines with blades in good condition while the most significant damage was detected for the two turbines with greatest level of root crack damage.

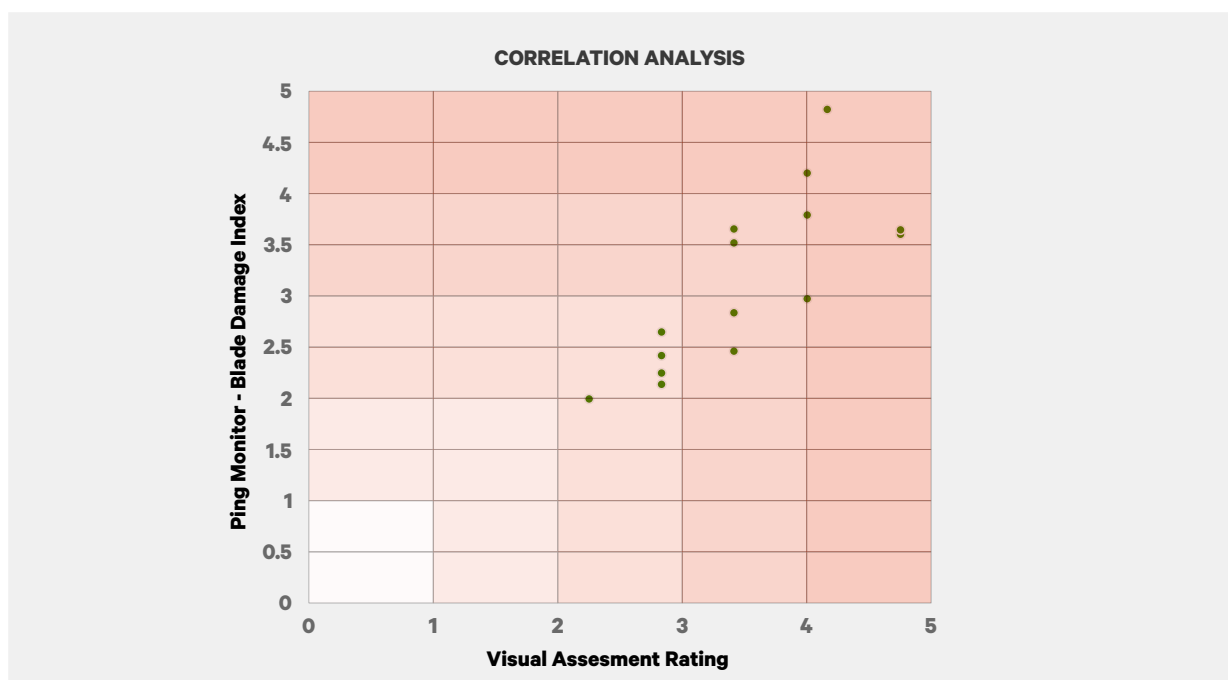
As part of the Ping Monitor continuous improvement and refinement of the damage detection ranking algorithm, a detailed correlation between Ping Monitor measurements and current industry standard visual defect ranking is on-going. Early results show promising correlation between Ping Monitor and trial site inspection data sets. More analysis is progressing at the time of writing.

Figure 8 - Early Correlation analysis between Ping Monitor and Visual inspection data
